**Reserve Study**  
**(Long Term Capital Replacement Plan)**  
**for**  
**Mammoth Point Condominium**  
**Homeowners Association**

**October 2011**

For the fiscal year beginning January 1, 2012  
*(Reserve Study with Site Inspection, Revision #2)*

Mammoth Lakes, CA

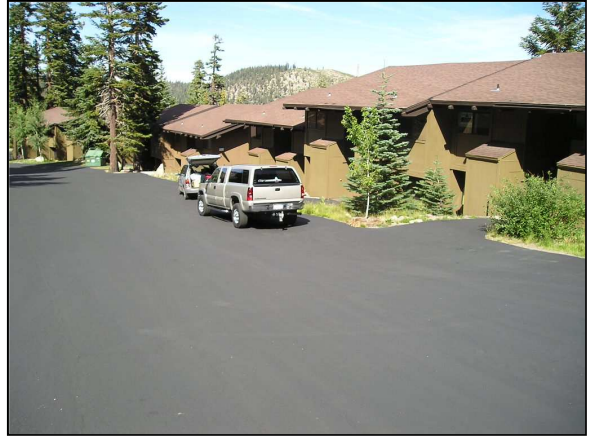
Asphalt Paving (Sealcoated in 2011)

<b>Location:</b> Private drives & parking.	<b>Quantity:</b> 34,815 SF + \$1,000 for hot crack pour.
<b>Remaining Life:</b> 1 Year.	<b>Typical Useful Life:</b> 2 Years.
<b>Comments:</b> The association applies asphalt sealcoat every 2 years. In order to preserve the integrity of the asphalt surface, it should have a sealcoat application no less than every 2 years in Mammoth due to skip loader and car chains causing wear & tear on the surface. Black Gold's typical cost per SF for sealcoat is about \$0.12-\$0.15/SF. There is also the need to do crackfill in the transverse cracks. Done in 2008 for about \$7000 and in 2011 for \$7300 (\$1700 repairs and about \$3,185 paths done also).	
<b>Current Replacement Cost:</b> \$7,300 Per 2011 cost.	
<b>Preventative Maintenance:</b> Regular sealcoat. Keep clean to reduce abrasive effects of grit.

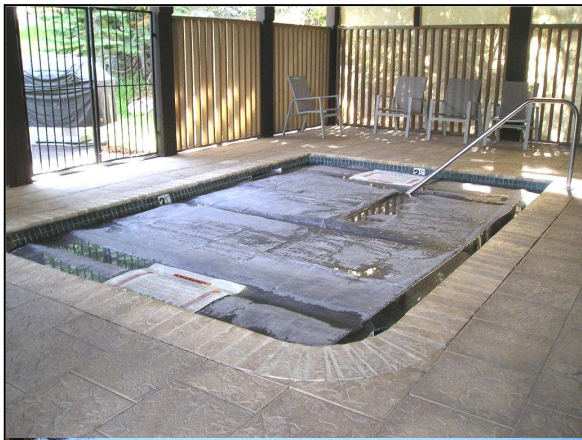
Enclosed Spa Area (Renovated in 2009)

<b>Location:</b> Spa area.	<b>Quantity:</b> 1 Spa replaster or fiberglass resurfacing.
<b>Remaining Life:</b> 9 Years.	<b>Typical Useful Life:</b> 12 Years.
<b>Comments:</b> The spa was completely renovated in 2009 for \$66K, but that included replacing deck surface, heater/filter/pumps plumbing and coping and tile. Hereafter, the spa will need resurfacing/retiling. Fiberglass-coated pools/spas are chemically inert and less prone to staining and tend to last longer and don't have the cold-joint bonding issues that you have with new plaster on top of old plaster.	
<b>Current Replacement Cost:</b> \$12,000 at \$12,000 per Spa replaster or fiberglass resurfacing.	
<b>Preventative Maintenance:</b> Maintain proper spa water chemistry. Higher acid content etches surface.

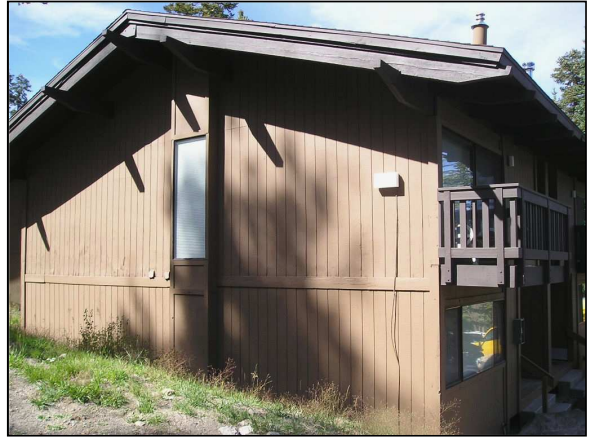
Siding & Wood Trim - Paint

<b>Location:</b> Building wood trim & siding.	<b>Quantity:</b> 1 Wood Trim/Siding Exposed Sides.
<b>Remaining Life:</b> 2 Years.	<b>Typical Useful Life:</b> 6 Years.
<b>Comments:</b> Error! Cannot open file.	
<b>Current Replacement Cost:</b> \$6,500 Per prior costs.	
<b>Preventative Maintenance:</b> Regular inspection and paint touch up to protect surfaces.

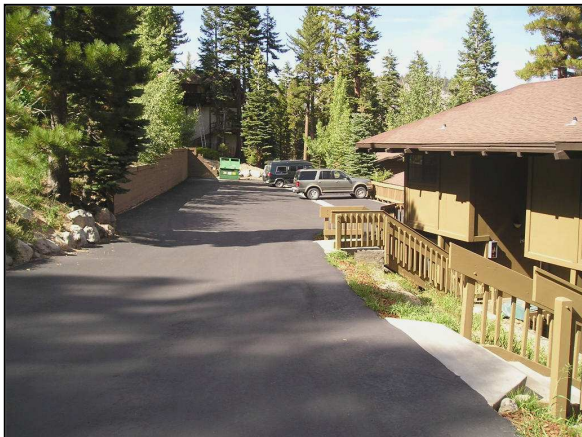
Upper Parking Lot & Wood Railings

<b>Location:</b> Wood parking lot border fencing.	<b>Quantity:</b> 258 LF.
<b>Remaining Life:</b> 1 Year.	<b>Typical Useful Life:</b> 35 Years.
<b>Comments:</b> The wood parking lot border fencing along both upper and lower parking areas is starting to deteriorate and become a bit wobbly in places. Assume it can be repaired to last a few more years and then be replaced in conjunction with front entry landing & stairway railings. HOA plans to schedule replacement in about 2013 with a \$10,000 allocation.	
<b>Current Replacement Cost:</b> \$10,060 at \$39 per LF.	
<b>Preventative Maintenance:</b>

<b>Location:</b> Private drives & parking.	<b>Quantity:</b> 5,945 SF.
<b>Remaining Life:</b> 12 Years.	<b>Typical Useful Life:</b> 22 Years.
<b>Comments:</b> The upper parking lot is still in good condition as of 2011 and probably can last 10-14 years before needing an overlay.	
<b>Current Replacement Cost:</b> \$14,860 at \$2.50 per SF.	
<b>Preventative Maintenance:</b> Regular sealcoat. Keep clean to reduce abrasive effects of grit.

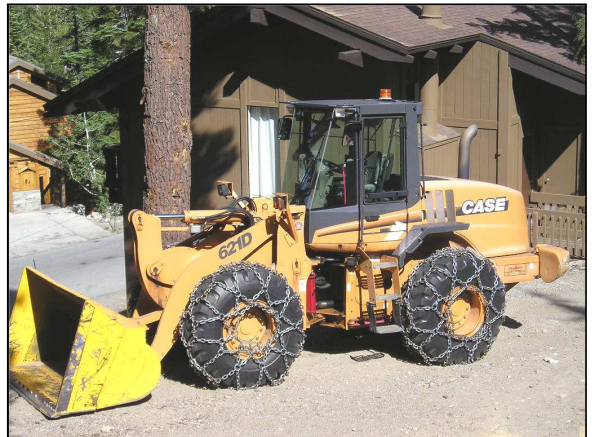
Snow Removal Equip: Case Loader
